Manhole Inspection Summary

Manhole # S250O1014MH

Insp Date: **12/18/06 9:13 AM**

Location Address: **4608 ROLAND AVE**

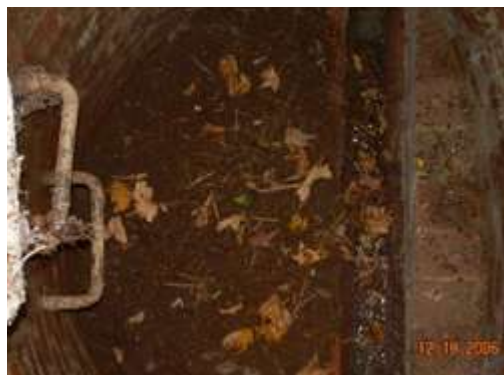
Top View

Barrel root intrusion. Evidence of surcharge - Bench debris. Channel debris.

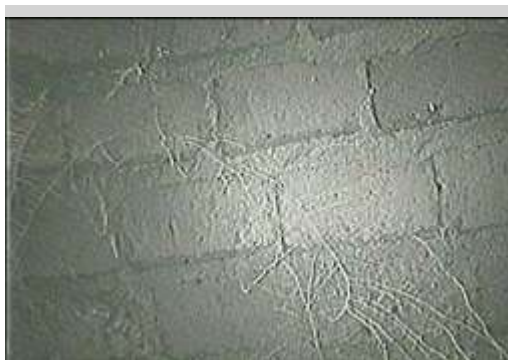
Defect

Barrel deterioration, root intrusion and infiltration..

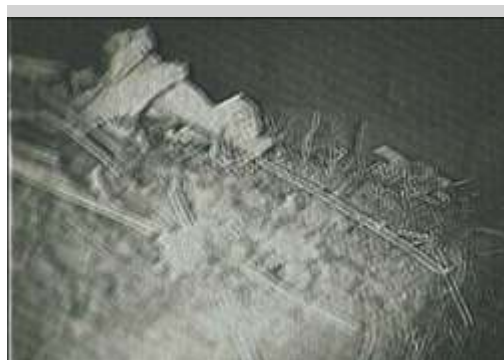
Defect

Bench root intrusion. Bench debris.

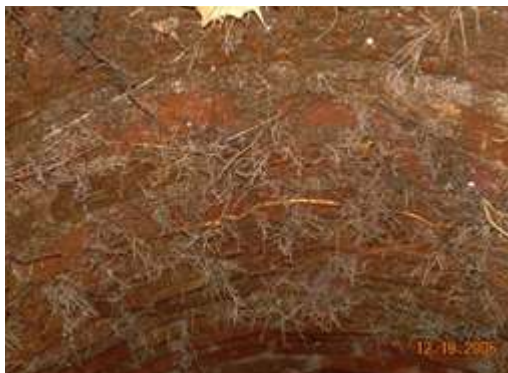
Defect

Adjustment and Corbel root intrusion and infiltration.

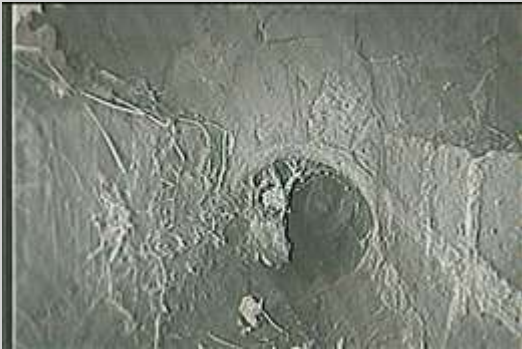
6 in. Circular Gravity Sewer Pipe Out @ 12 O'Clock

Infiltration: **None** Pipe Seal Cond: **Roots**

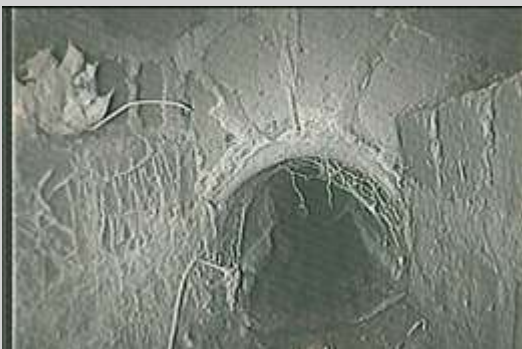
6 in. Circular Gravity Sewer Pipe In @ 6 O'Clock

Channel root intrusion.

Infiltration: **None** Pipe Seal Cond: **Roots**
